IMPORTANT NOTE

Fitment of the Night Hawk VLI Wiring System to Ford Ranger, Volkswagen Amarok, Jeep Wrangler

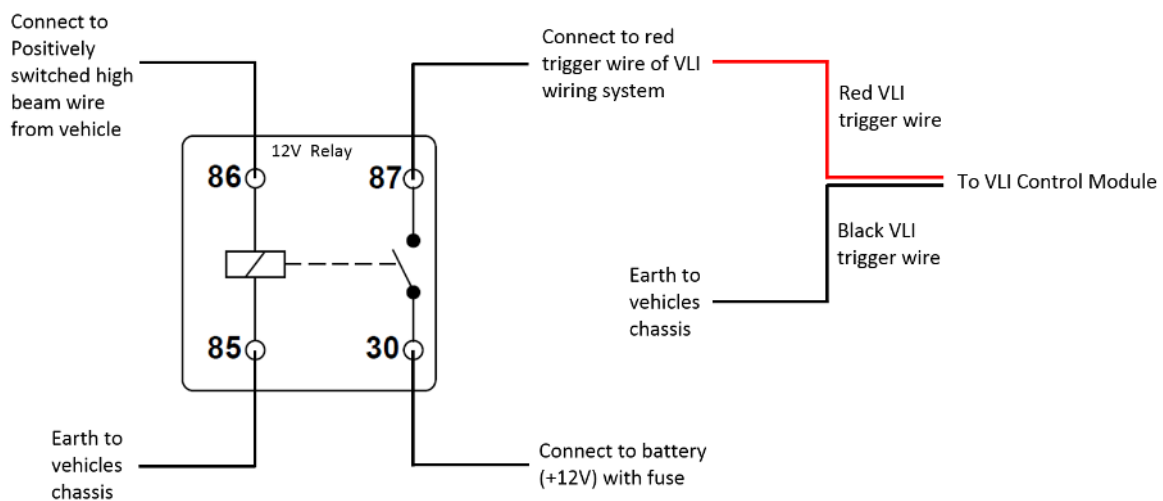
Wiring Diagram

The symptom of the fault is intermittent operation of the VLI lights – when the high beam is switched on, the VLI lights may turn on sometimes, but not others. On Ford Ranger's, it has been observed that this fault only occurs when the engine is running and it may be similar on other models listed. The fault is due to an incompatibility between the PWM high beam signal coming from the vehicle and the control module in the VLI wiring system.

Diagram shown below is for a positively switched high beam signal coming from the vehicle.

The solution to fix this fault is to firstly check if this fault is present on the vehicle, and if it is, use a 12V relay in between the high beam signal and the VLI trigger wires. The high beam signal coming from the vehicle is used to energise the coil in the relay, and the switched circuit is used to provide a 'clean' 12V signal from the battery to the VLI trigger wires. A basic wiring diagram is provided below.

We recommend to use a readily available 15/20/30/40A automotive 12V relay with diode or resistor for spike protection, but it is important to note that a high current relay is not completely necessary since the VLI system draws very little current and is supplied with a 2A inline fuse on the red trigger wire.
